# INTERSTATE 5 LIFT SPAN TRUNNION REPLACEMENT

## 2019 REPLACEMENT

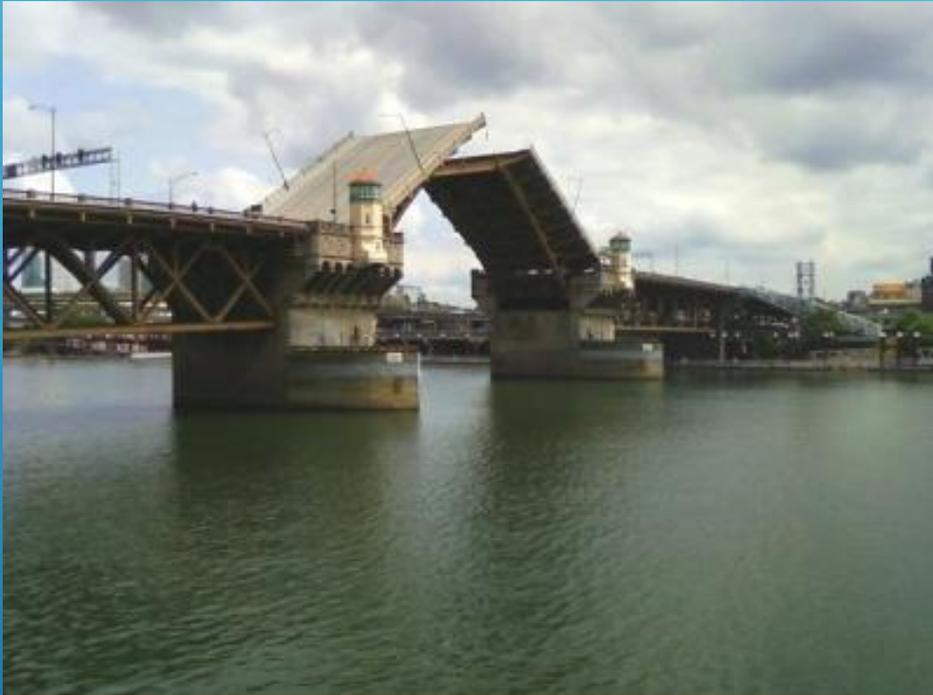
## 3 MAIN TYPES OF MOVABLE BRIDGES

Most common is the bascule style

Typically used for shorter span lengths

Offers unlimited vertical clearance

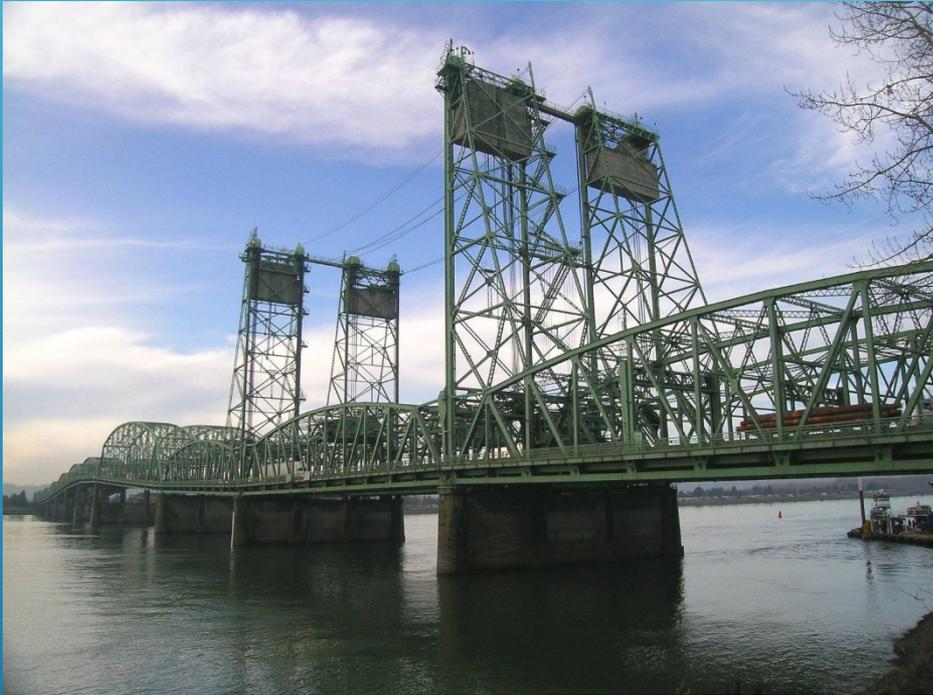
## 3 MAIN TYPES OF MOVABLE BRIDGES

Vertical lift bridges are also quite common

This style is often used for longer span lengths

Have limited vertical clearance

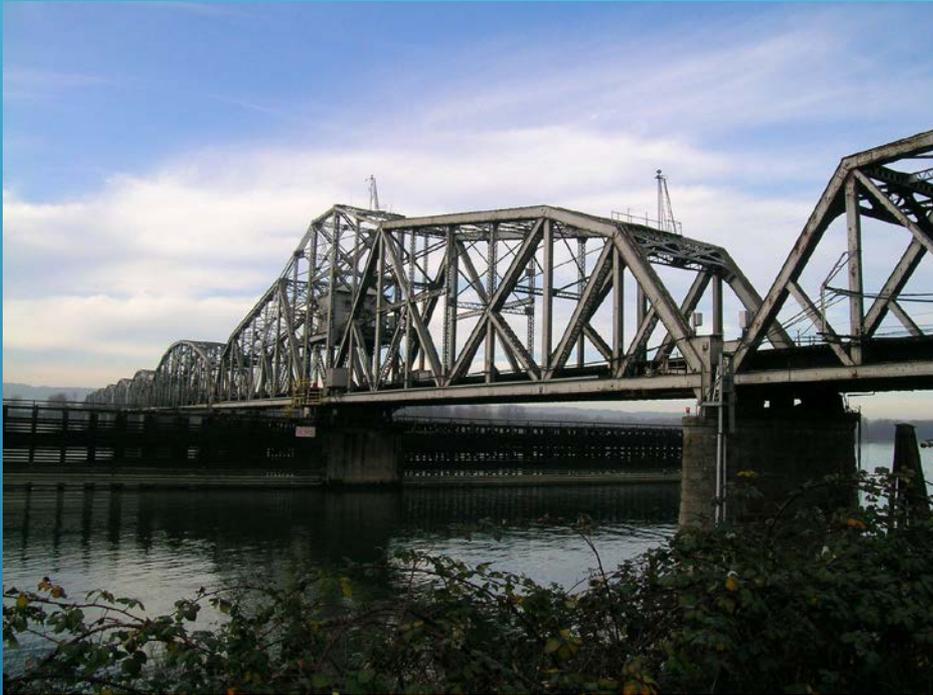
## 3 MAIN TYPES OF MOVABLE BRIDGES

Swing spans are less common  
than bascules or lift spans

Often used for longer spans

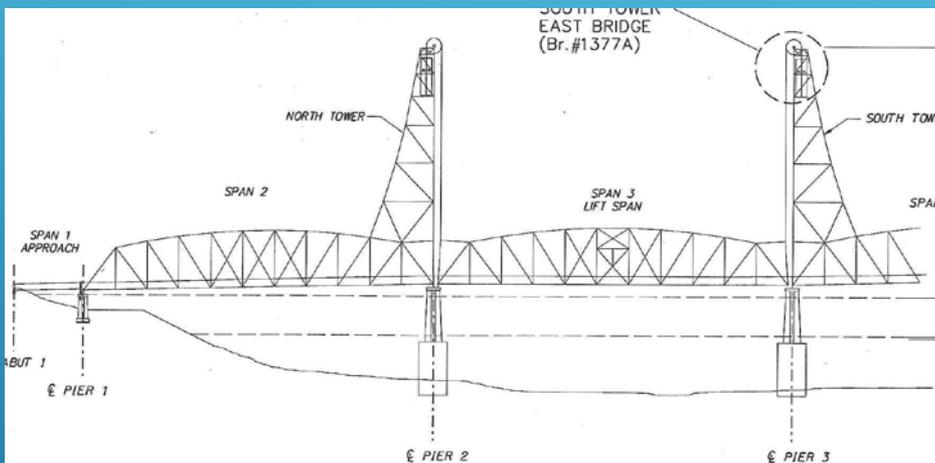
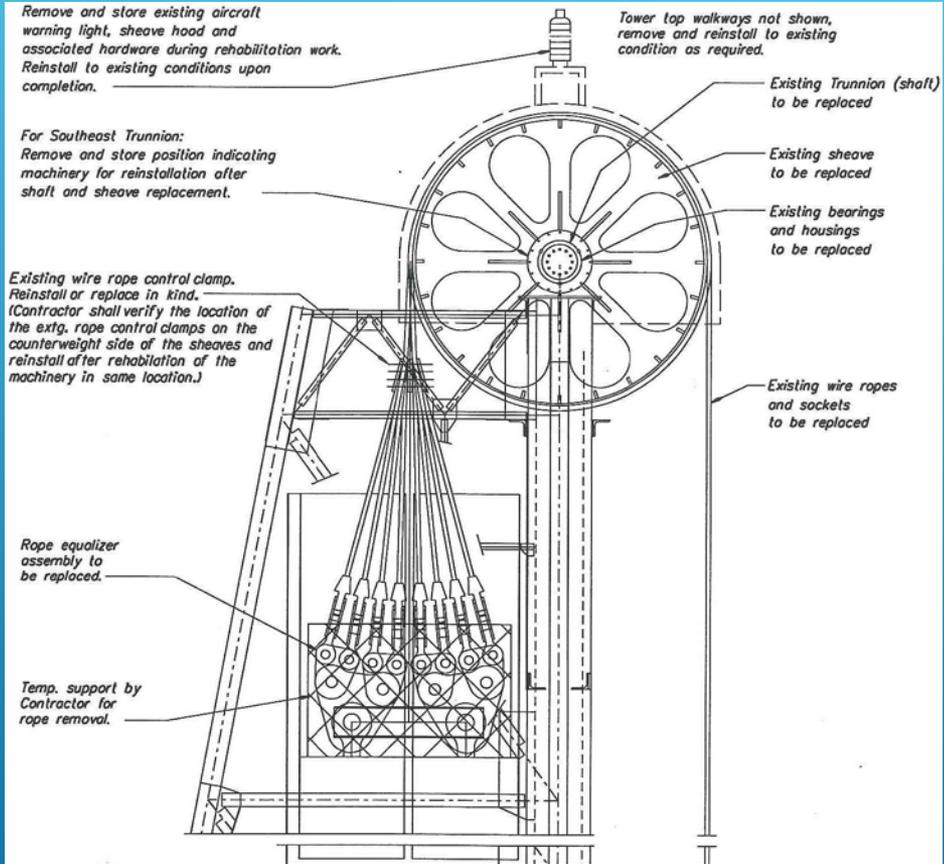
# LIFT SPAN OPERATION

The lift span is balanced by the counterweights in each tower

The lift span is connected to the counterweights via large wire ropes

The wire ropes pass over the sheave/trunnion assemblies which allow low friction motion for raising and lowering the lift span

As the span goes up, the counterweights go down and vice versa

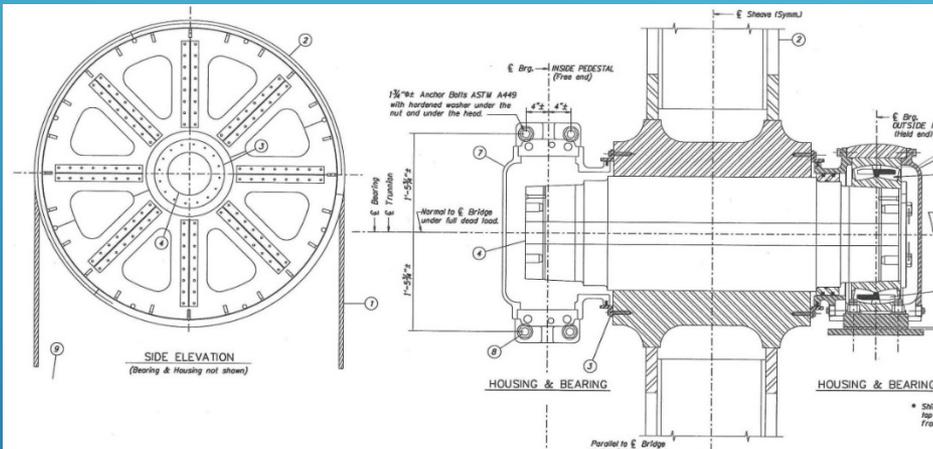
# TRUNNION IS SUPPORTED BY BEARINGS

The trunnion is fixed to and rotates with the sheave

At each end the trunnion is supported by bearings to allow low friction rotation

Shown here are modern rolling contact bearings

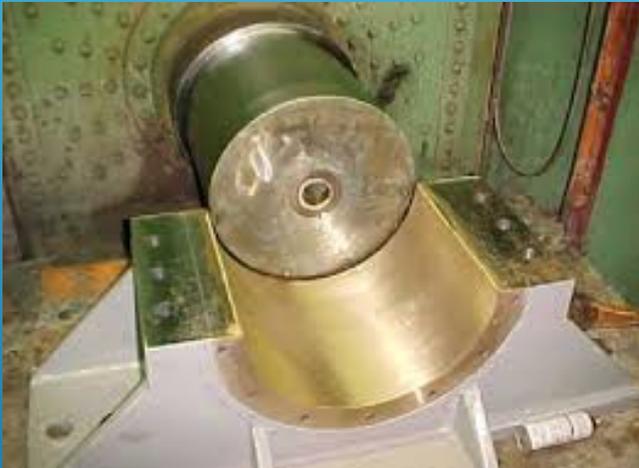
# BEARING DESIGN HAS CHANGED OVER THE YEARS

The original bearings in the Interstate bridge ( built in 1917) used a plain steel journal riding in a bronze bushing

Grease between the journal and bushing provides for relatively low friction

Circa 1950's rolling contact bearings became more commonly used due to extremely low friction compared to the old plain journal / bushing style bearings

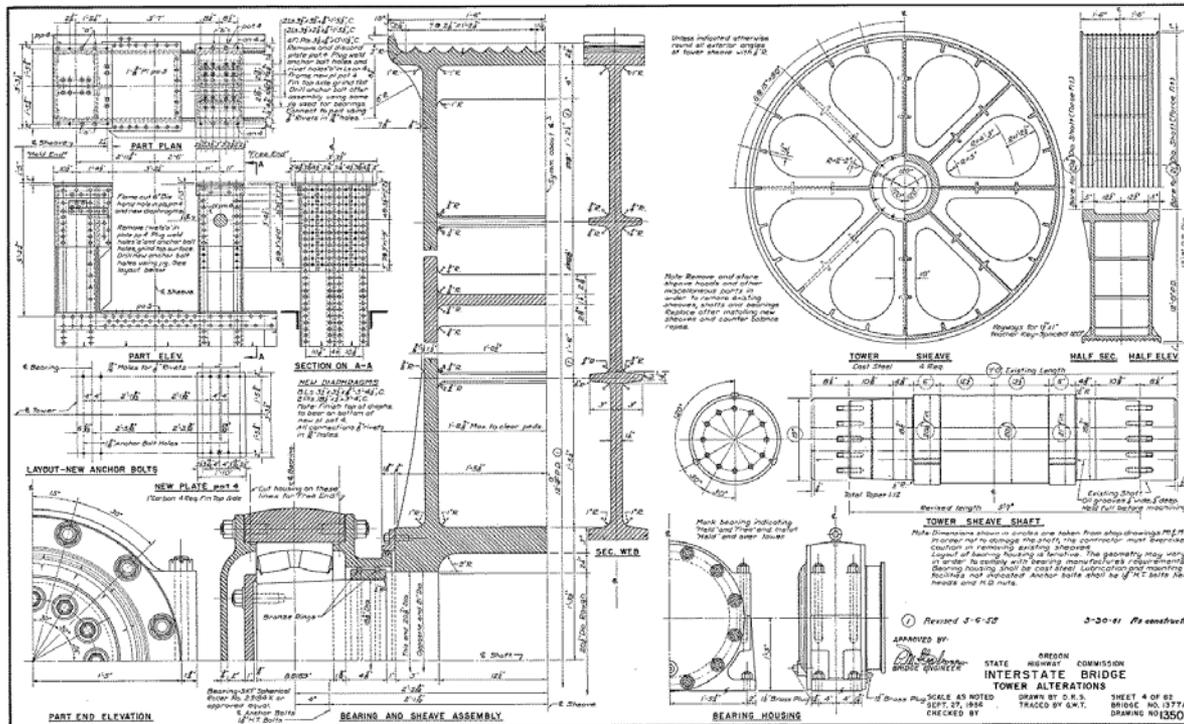
# 1958 CONVERSION TO ROLLING CONTACT BEARINGS

New sheaves and bearing were installed in 1958.

The original trunnion shaft was welded and machined to accommodate the new rolling contact bearings.

Poor welds located in high stressed regions of the trunnion eventually lead to fatigue cracking of the trunnion.

The trunnions on the north tower cracked first which was discovered in 1994.

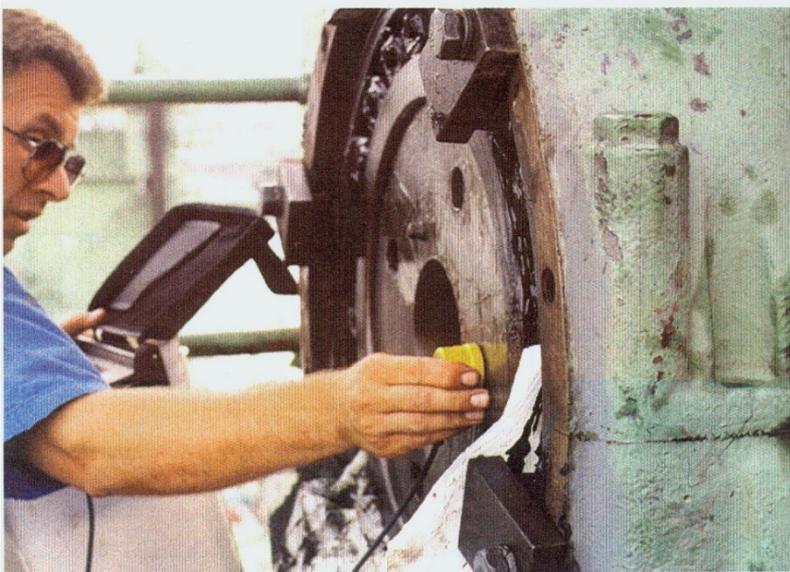
Fig 1.2 – 1997 UT examination of northeast trunnion (east face)

## ULTRASOUND USED TO INSPECT FOR CRACKS

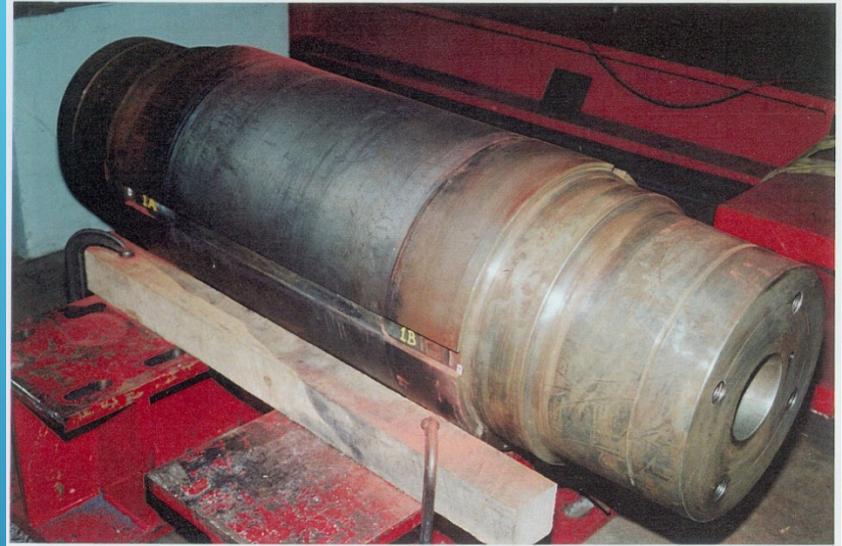
Fig. 3.4 – Trunnion after removal from sheave and prepared for NDE

## NORTH TRUNNION READY FOR FORENSIC ANALYSIS 1998

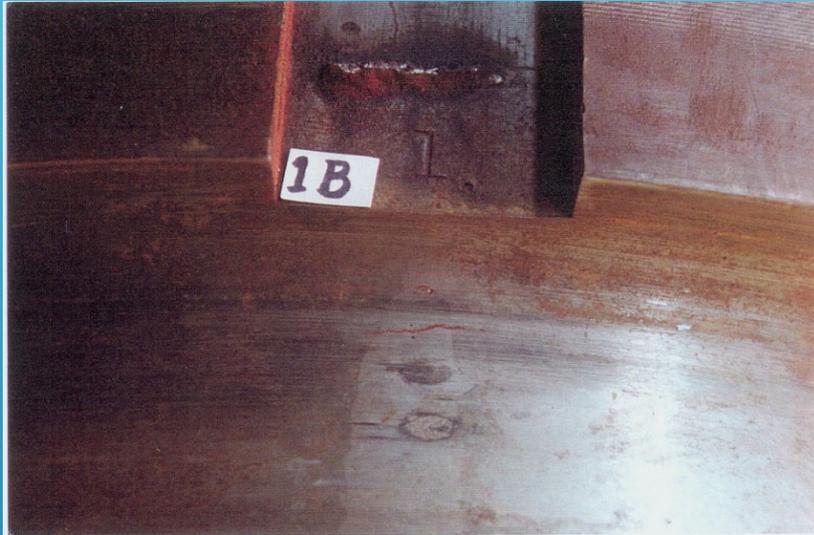
b) Defect 1B. Note dissimilar metals defining the weld filled oilway

Fig. 3.5 – Defects at keyways detected by MT examination

## WELDED GREASE GROVE DEVELOPS CRACK

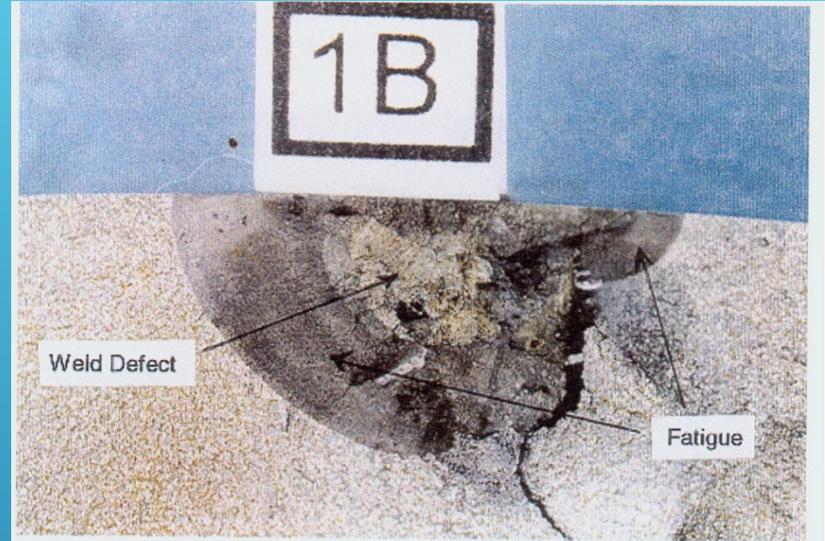
Fig. 4.2 – Initial defect at keyway 1B with fatigue crack extension after ultrasonic cleaning. (ATLSS)

## SECTION OF ACTIVE CRACK

# 1998 FORENSIC ANALYSIS FINDS FATIGUE CRACKS IN TRUNNION

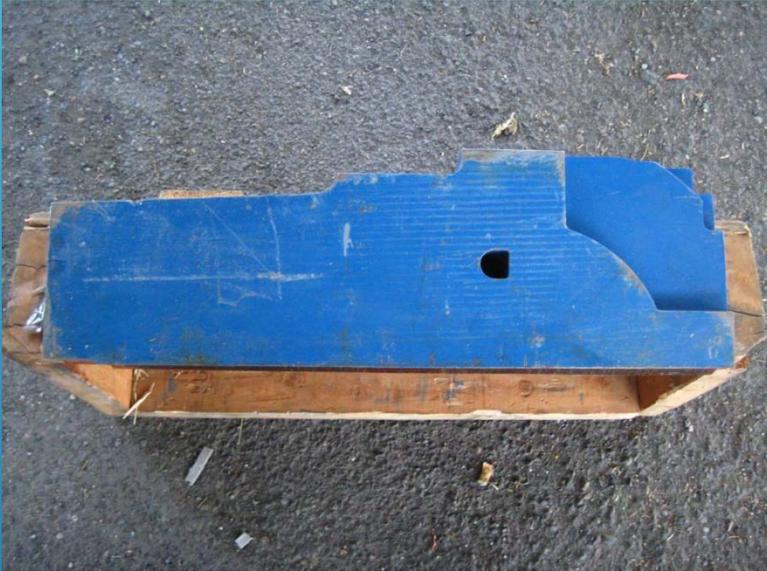
With knowledge gained from the 1998 forensic analysis of the cracked trunnion a much improved Ultrasonic Testing procedure was developed

This testing has allowed ODOT to monitor the two trunnion shafts on the south tower

Small cracks were first detected in 2011 and have been monitored since

# OLD TRUNNION PROVIDES NEW IMPROVED INSPECTION CAPABILITY

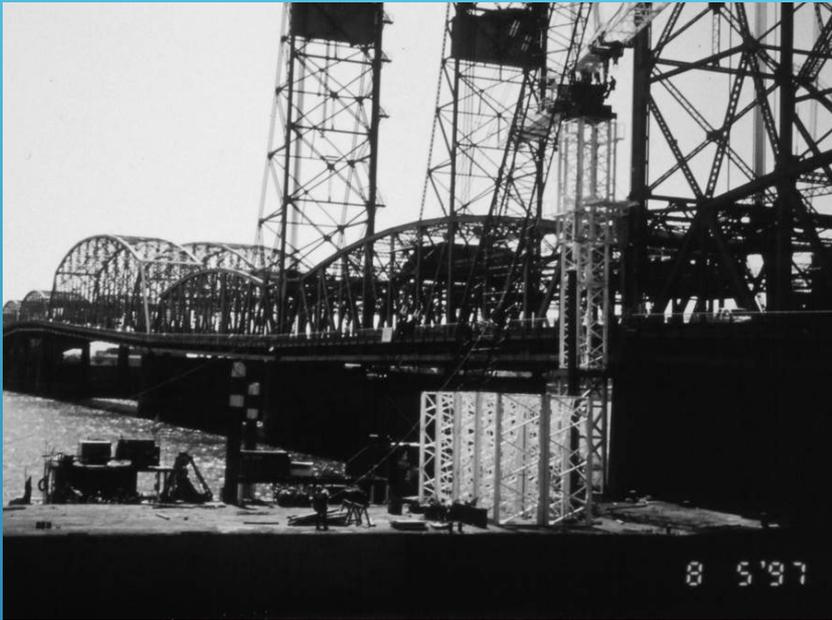
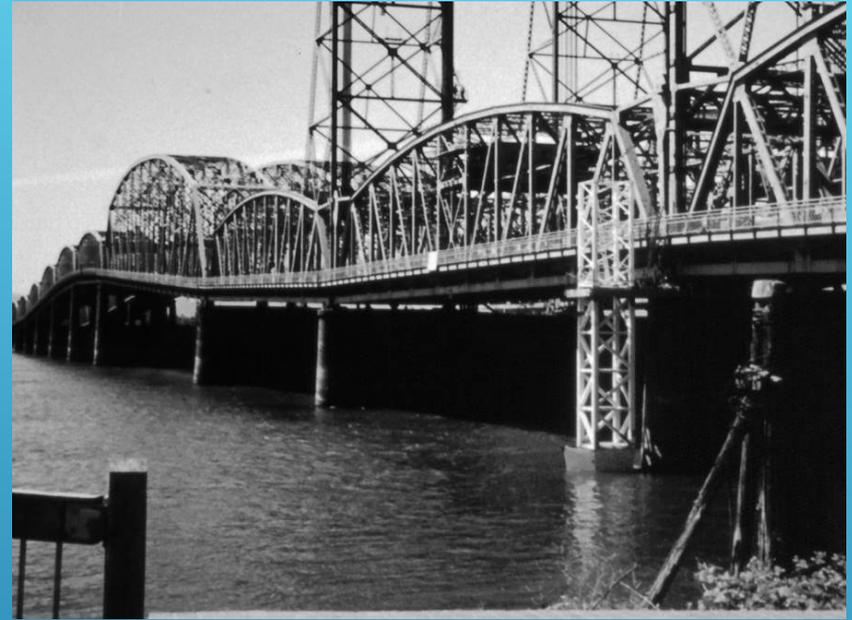
# FABRICATE NEW COMPONENTS

- ▶ Fabricate new sheaves, trunnions, bearings, wire ropes to replace existing on south tower
- ▶ Fabricate temporary counterweigh support structure
- ▶ Install support structure
- ▶ Shut bridge down and replace equipment on south tower
- ▶ Open bridge and remove temporary works

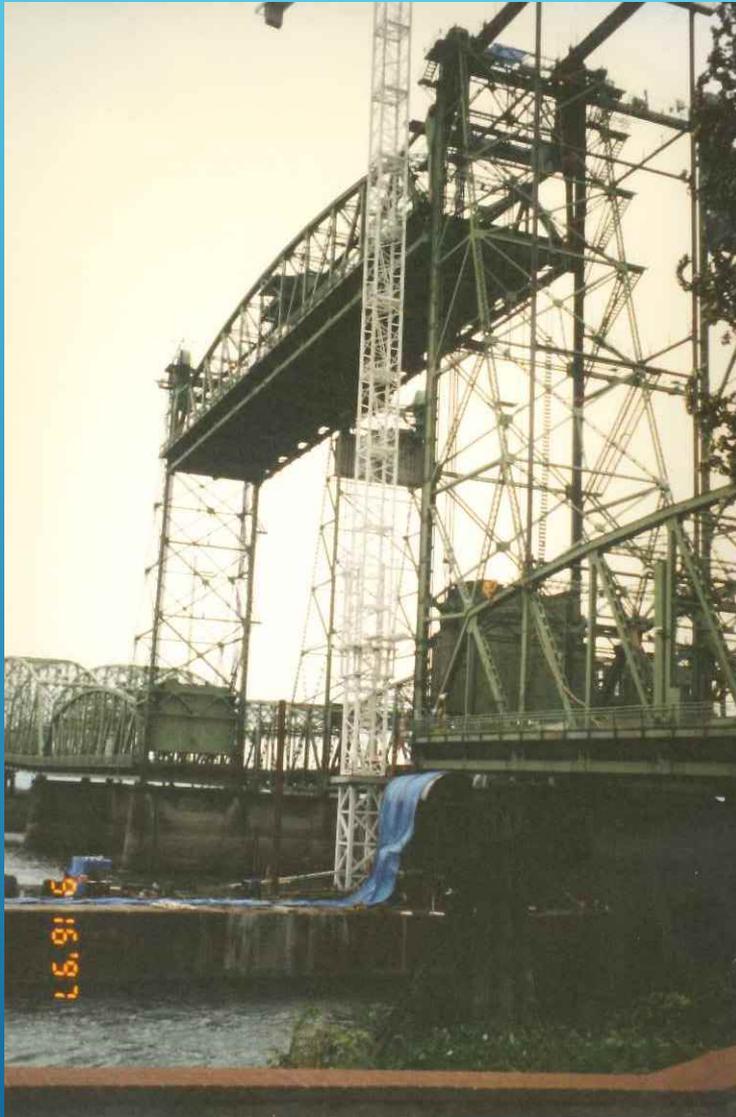
## TEST OPERATION OF LIFT SPAN

After installation of the new machinery the lift span is tested for proper function

Once accepted the bridge can be opened to vehicular and marine traffic

The counterweight support structure will be removed with minimal impacts on traffic
